# TECHNICAL BULLETIN

## EXPANSION JOINTS FEA - DUAL HINGED EXPANSION JOINTS

### PIPING TECHNOLOGY & PRODUCTS, INC.

Stress analysis was performed on a dual hinged expansion joint to determine whether the plate thicknesses are sufficient to insure that the stresses are within code allowable.

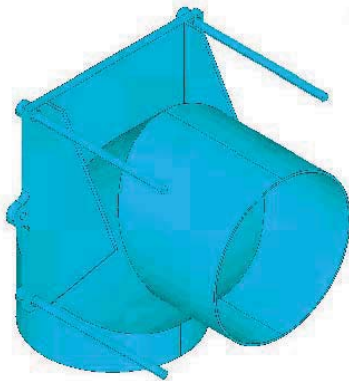
**Figure 1.**  
Portion of a 36 inch Bellows assembly (EJ-004)

**Figures 1 and 2** show a portion of a similar dual hinged expansion joint that was built by U.S. Bellows, Inc. The figures show the connection of the tie rods to the bellows. The tie rods are connected to a plate-gusset assembly, which is welded to the bellows. This note describes a stress analysis to determine whether the plate thicknesses are sufficient to insure that the stresses are within code allowable.

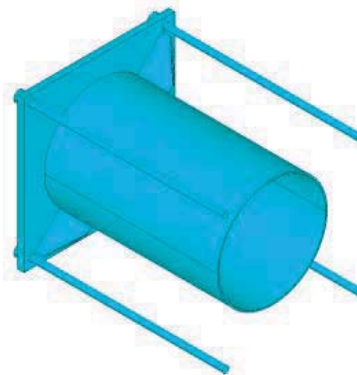
**Figure 2.**  
Portion of a 18 inch Bellows assembly (EJ-009)

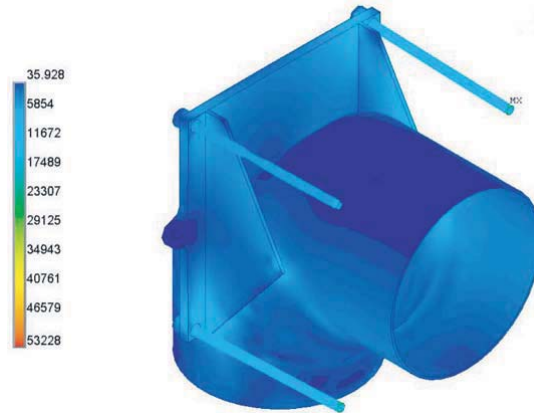
The results for EJ-004 are shown in **Figures 3, 4, and 5**. **Figure 3** shows the stresses in the complete assembly.

**Figure 3.** Von Mises Stresses for complete assembly.

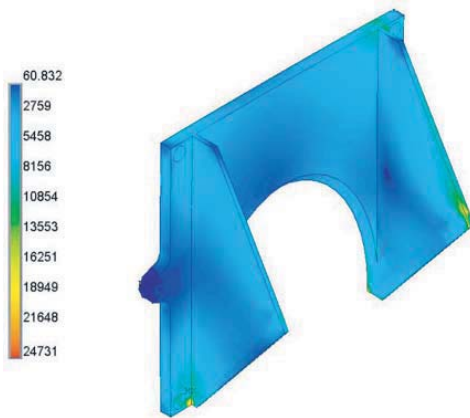
**Figure 4.**  
Stresses in the plate-gusset assembly of EJ-004 (Front View)

The stresses on the assembly are all nearly below the allowable. There are two small areas where there are stress concentrations, but the areas are small, and the stresses drop rapidly away from the peak. These local areas should not be of concern.

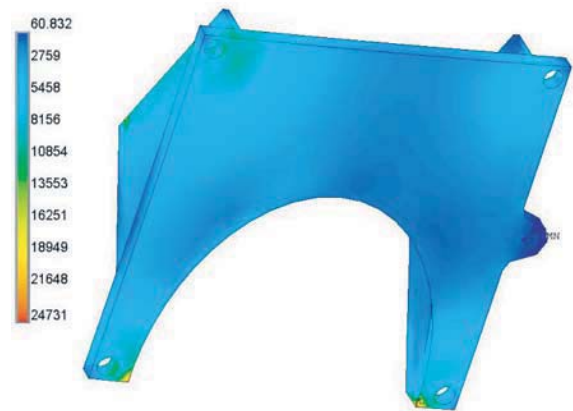
**Figure 5.**  
Stresses in the plate-gusset assembly of EJ-004 (Back View)

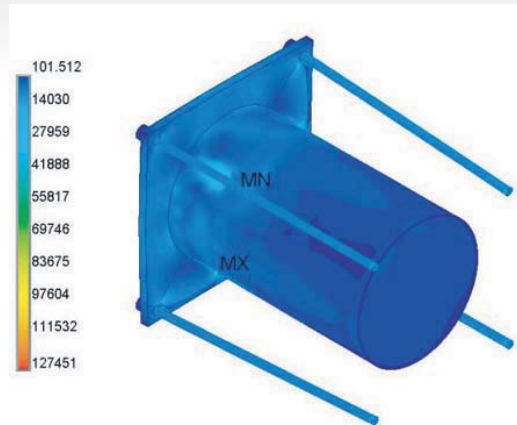
**Figure 6.** Stresses in the complete assembly for EJ-009

**Figure 6** shows the stresses in the complete portion of the assembly analyzed. There are some quite high stresses shown. These are in the pipe at the tip of the gussets. They are clearly due to very large change in stiffness at that point, - from 3/8 in. in the pipe to 1 7/8 in. at the tip of the gusset.

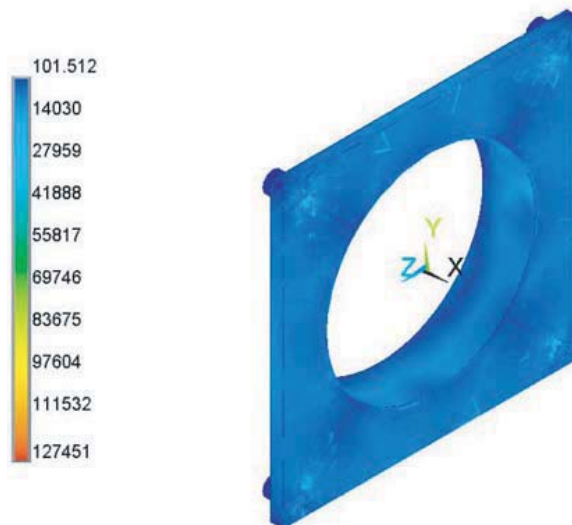
**Figure 7.** Stresses on the tie rod plate for EJ-009

**Figure 7** shows the tie rod support plate. The stresses are all clearly below the allowable. In conclusion, the thickness of both plates analyzed are adequate.
